# For Sale

## Accucraft C-19 #346 with Green Boiler Jacket.

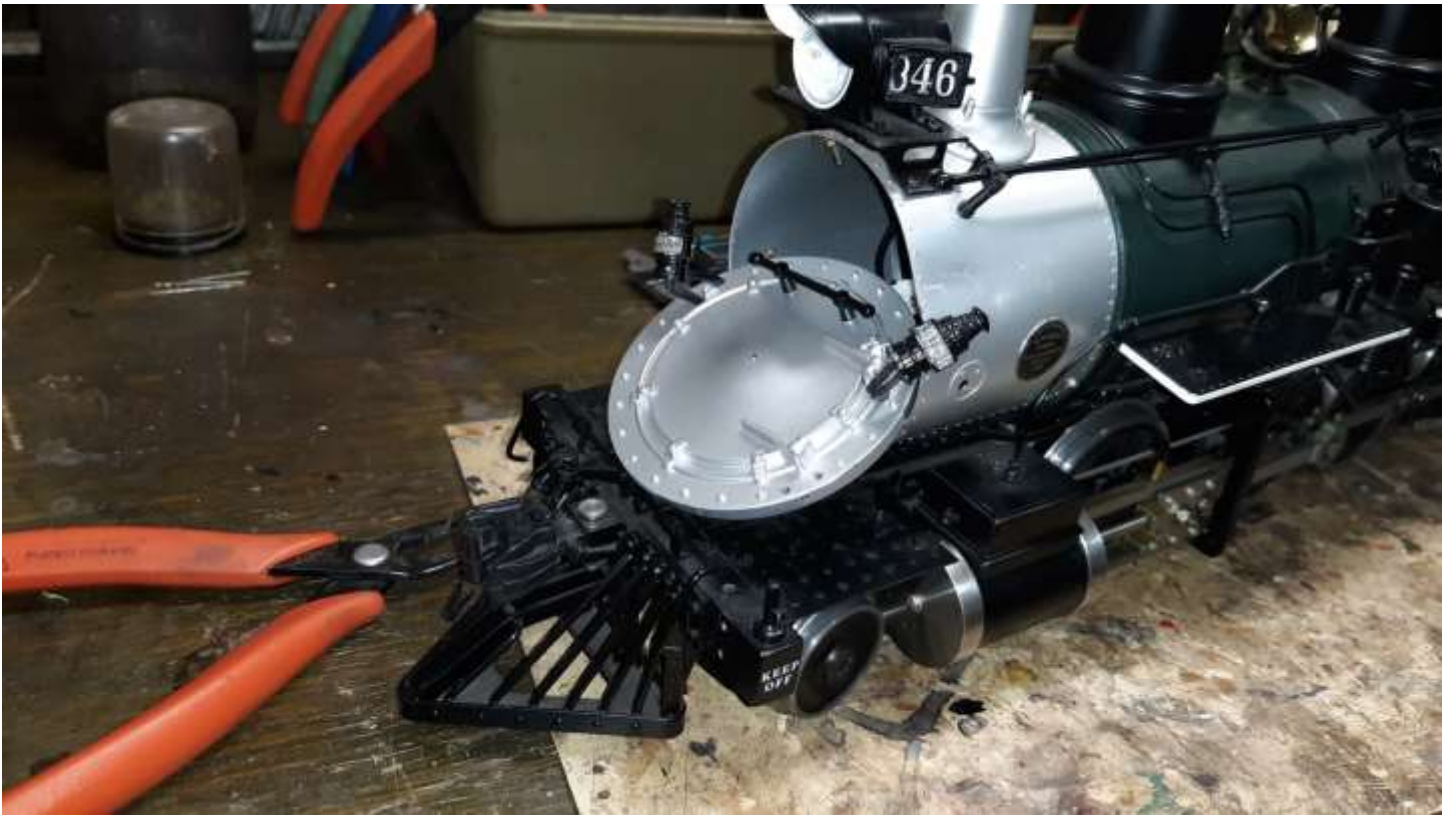
As seen below the front of this loco took a lot of damage.

Front steps were removed and straitened, and later reappplied.

Engineer's side flag post was sheared off, drilled out hole and rethreaded to 2mm, removed fireman's side and replaced with trackside details td-157, threading the shanks to 2mm.

Boiler front did not fit due to dented smokebox, marker light mounting posts were badly bent, and number plate was missing and sheared off. (The step was present but not shown in photo) I drilled out the remaining number plate stud and chased the hole with 2mm tap. I made new marker light mounting posts from brass rod, and made a 3d model of a 16" number plate, and rather than apply a decal included the number in the 3d print. Both mounting screws for the boiler front were broken off in the front, but I was able to extract and clean up threads for remounting.

The Boiler braces were nonexistent, so new ones had to be made from brass rod. Apparently on this model they changed the design from the first one I had in that the braces were fitted into a hole in the end beam. I decided bolted boiler braces would look better, so they were secured over the existing holes.

Headlight: one of the support brackets was found to be loose and re-soldered.

Smokebox: this was the biggest challenge, but I was able to reform it back into shape with only the smallest amount of Solder filler in a couple of spots.

The entire smokebox and front were resprayed with a more appropriate graphite color before reassembly.

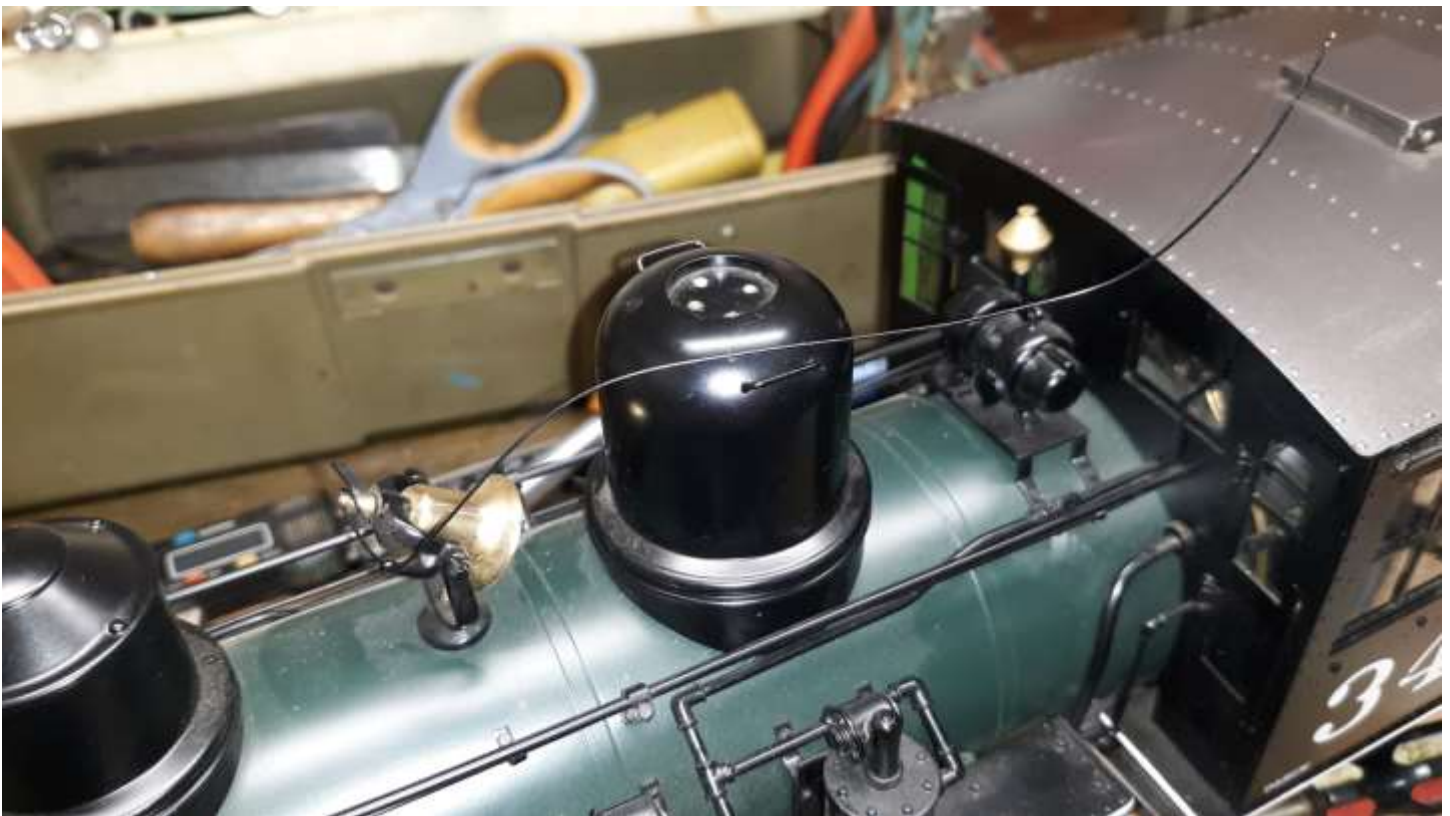
The next major area of concern was the steam dome:

As the above picture shows the top of the steam dome was completely striped, and the remains of the mounting posts sheared off at the top.

I made a 3d printed fixture to hold the dome in my mill, and center drilled the offending studs before drilling out and chasing with a 2MMM tap.

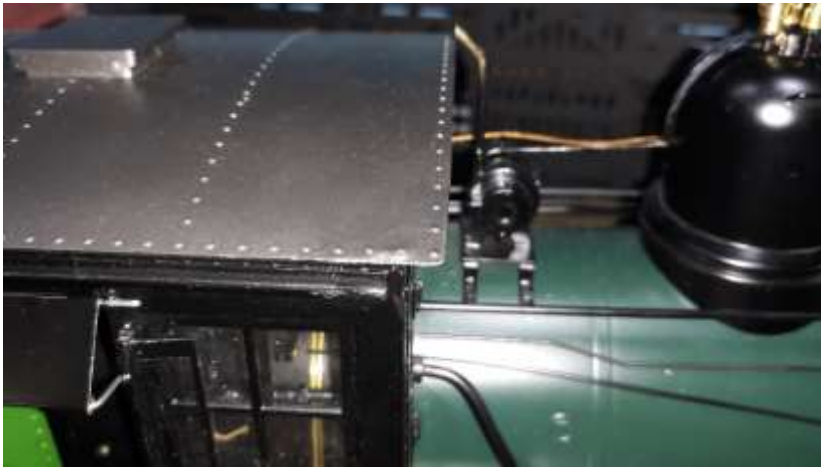
The cab initially looked pretty good; the only visible defects were a dent on the engineer's side front corner, and the fireman's read door was loose. Upon further inspection the cab end walls had been bent in due to the impact. I was able to gently bend them back into shape and re-soldered the loose cab door. All the cab doors did not fit very well and at first thought the whole cab was racked. Further examination however showed they apparently had not been fitted well at the factory, so I filed them for a better fit. The cab corner was straightened as best as could be done w/o complete disassembly of the cab and the entire cab roof resprayed with graphite paint.

The drawbar was bent as well and straightened.

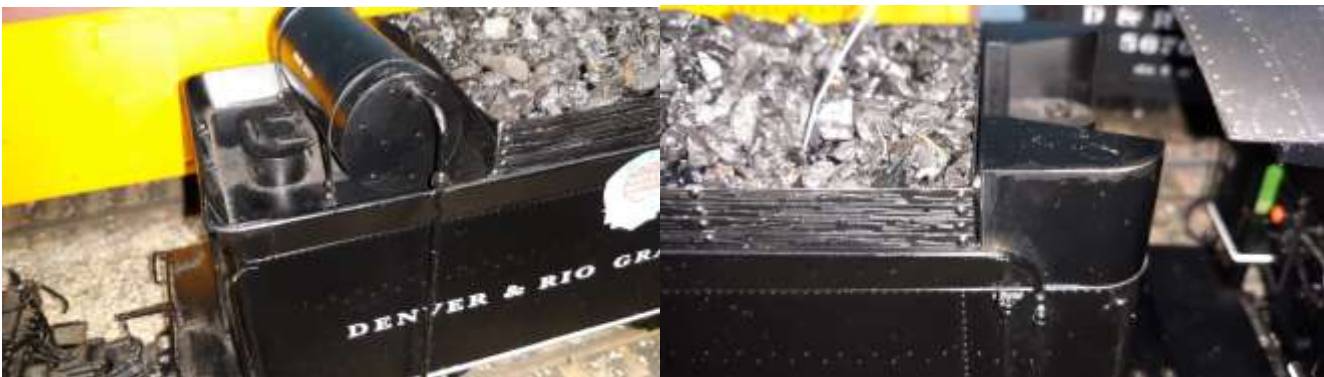
Several tender steps were bent and were unbolted and straightened before reassembly. There is one spot on the engineer's side of the tender that got a small dent that just got touch up, and the engineer's rear of the tender trim (half round) was disturbed and was brought closer to where it belonged but is not 100%.

Some of the air brake plumbing was also bent and straightened.
